ST3TART FOLLOW-ON: FIDUCIAL REFERENCE MEASUREMENTS (FRM) - S3 LAND ALTIMETRY	Ref	NOV-FE-1464-NT-092		
	Issue	1	Date	18/12/2025
	Rev	1	Date	15/01/2026
	Page	13/43

## 2 Campaign log

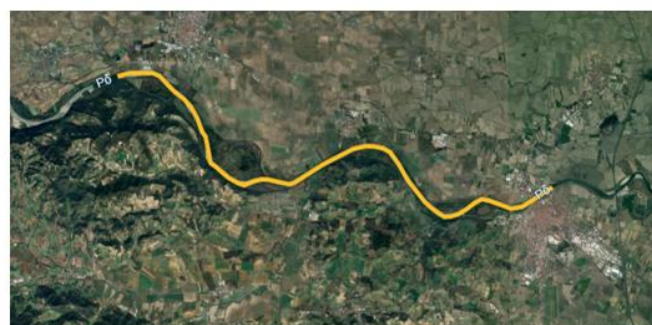
**Isola-Pescaroli super site**

**Pontestura super site**

**Figure 1: Flight plan of the campaign on Po River.**

Figure 1 and Figure 2 show the flight plan over the Po River and the Tiber River, respectively.

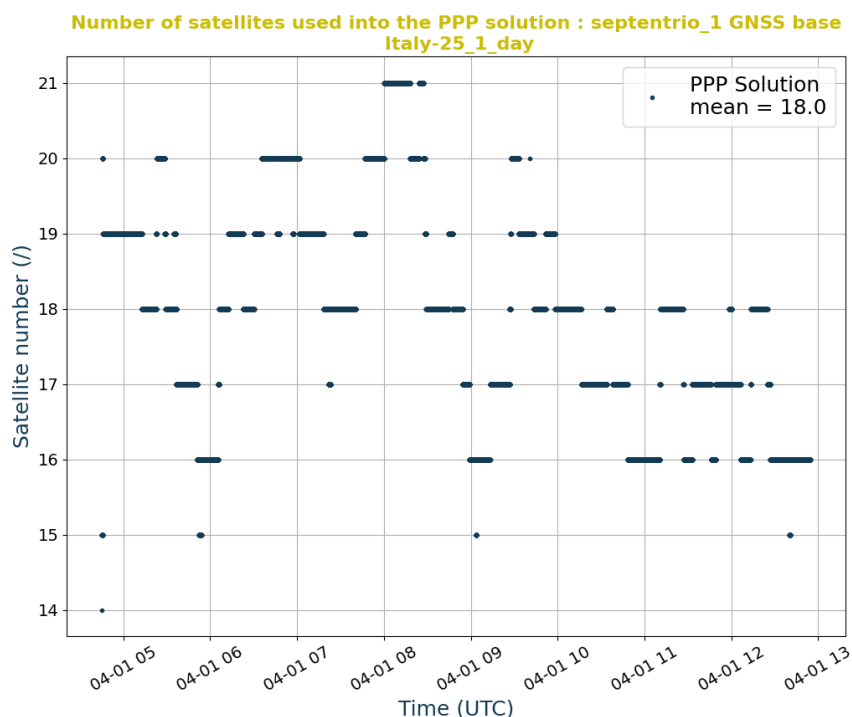
We obtained an excellent position for this base for the deployment day, with a standard deviation under a millimeter, with a mean of 18 satellites observed (Figure 4 and Figure 5).

Figure 4: Number of satellites used in PPP solution on Tiber campaign.

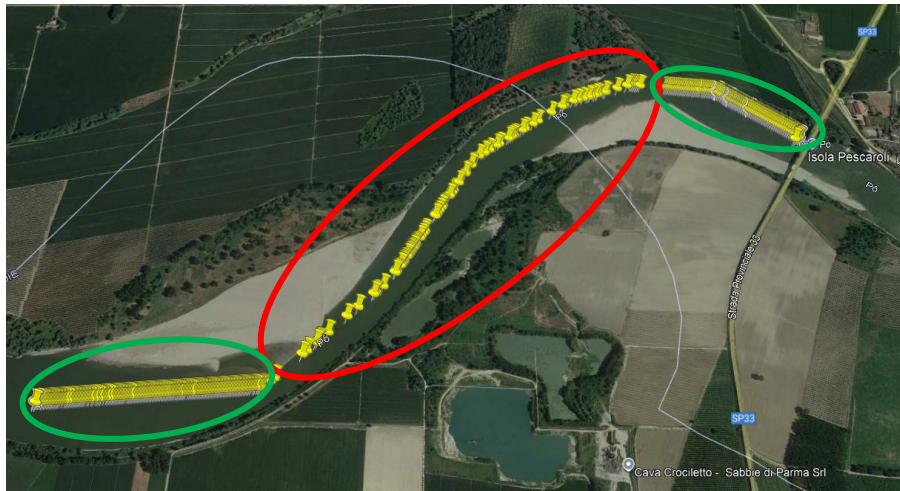
During the measurements performed at Isola Pescaroli, we also observed a problem of missing LiDAR measurements (Figure 12), which is distinct from the previously discussed missing data percentage. When no LiDAR backscattered signal is detected, the system records a NaN value, and the missing measurements percentage corresponds to the proportion of NaN values in the LiDAR time series. In this case, however, the LiDAR failed to produce any record for the clock tick. Only flights 131 and 134 were affected by this issue.

Figure 12: LiDAR measurements displayed on the map for flight 131 (in green: area without any LiDAR missing measurements; in red: area with missing measurements).

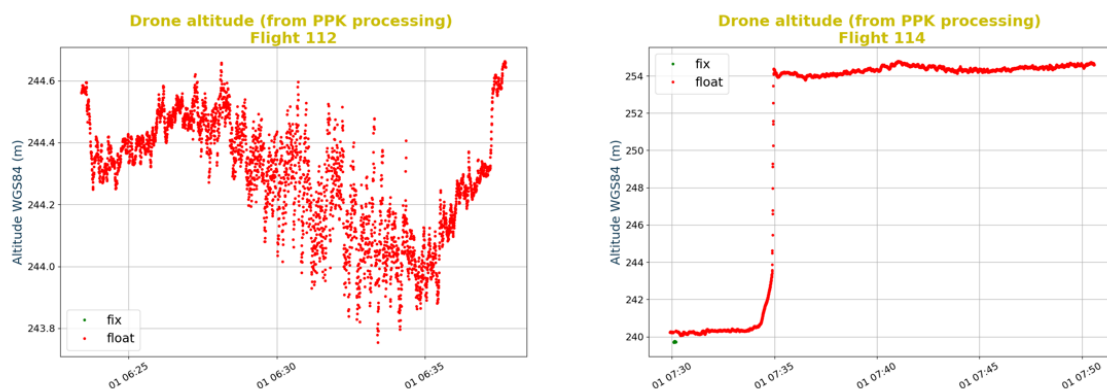
On Deruta flights (112 and 114), the ambiguities are not fixed as shown in Figure 13. We do not have strong confidence in the GNSS position obtained during these flights. On flight 112 (Figure 13, left panel), we observe very strong variability on the GNSS solution in the middle of the flight that does not describe the drone displacement.

Figure 13: Altimeter positioning (from PPK processing) on Deruta super-site.

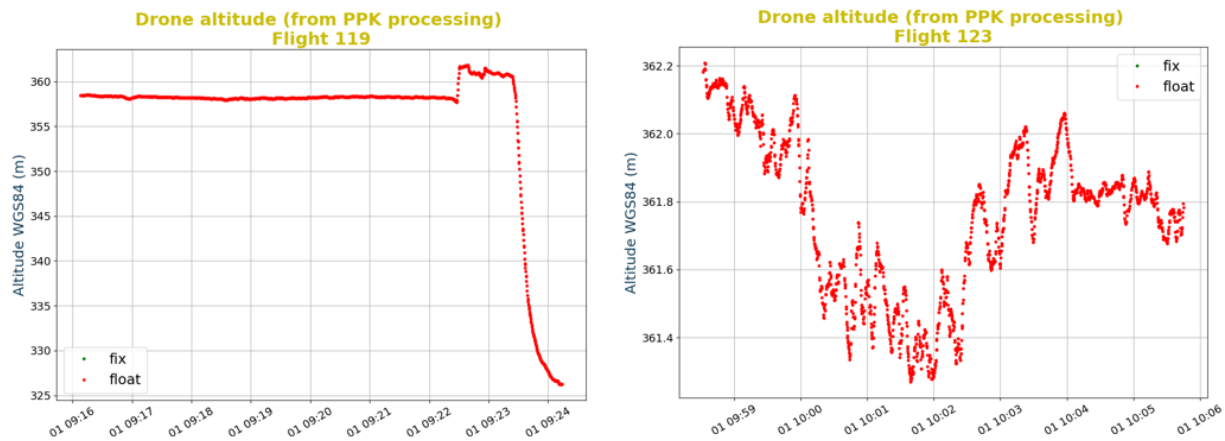
On Santa-Lucia super-sites (flights 119 and 123), we have the same issue as seen in Deruta; the ambiguities are not fixed (Figure 15). We do not have strong confidence in the GNSS position obtained. On flight 119, the sudden change in altitude at the end of the flight is due to the drone landing. The drone pilot should have stopped the measurements before landing to avoid editing a part of the flight on our side.

Figure 15: drone altitude (from PPK processing) on Santa Lucia super-site (flights 119 and 123).

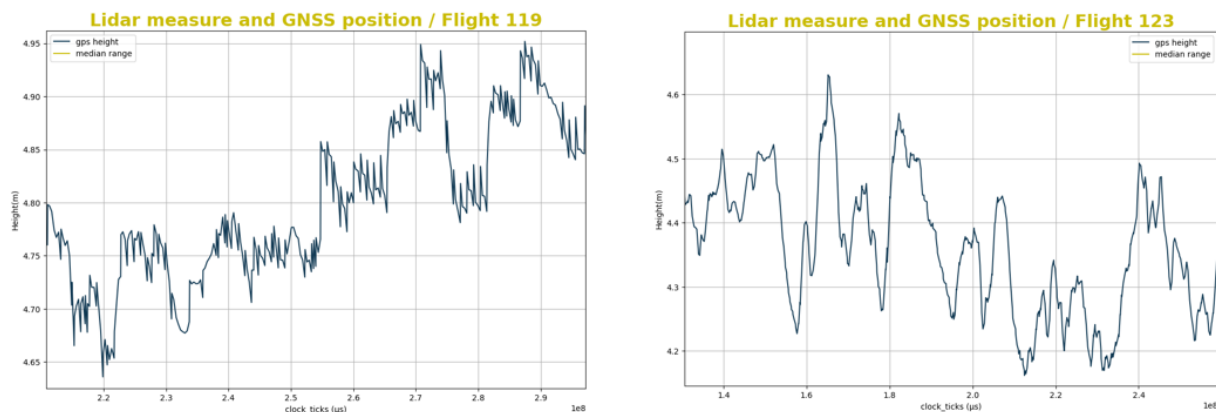
As on the other flights, we observe the noise in the position of the time series on flight 119, whereas flight 123 is not impacted by this noise. The amplitude of the noise is lower than that for flight 112, but it impacts the accuracy of the water surface height measured by the altimeter (Figure 16).

Figure 16: Lidar measure and GNSS position in Santa Lucia super-site (flights 119 and 123).

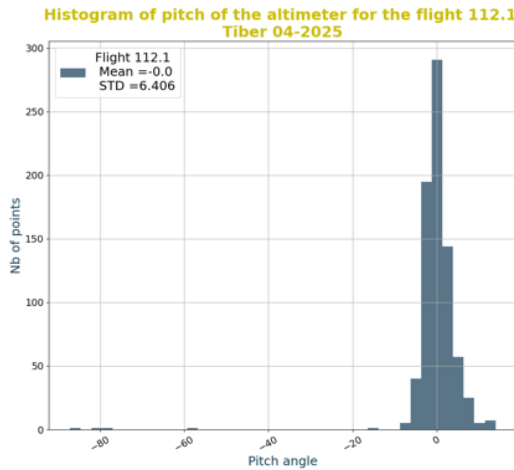
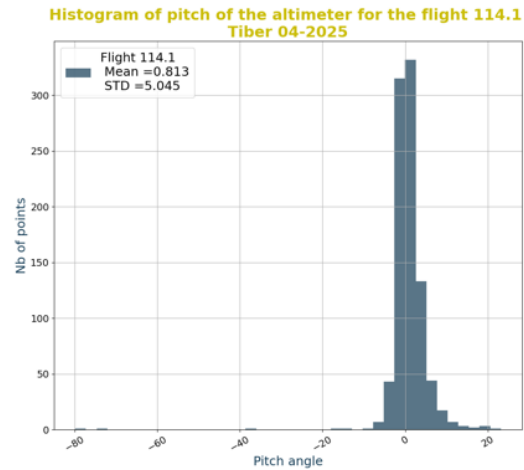
On both flights, the pitch is well-centred (Figure 26). The high variability in the flights is due to gimbal issues. We suspect that the gimbal can have some errors and block the stability to the min pitch ( $\sim -80^\circ$ ), which is the same behaviour as the one observed at Isola Pescaroli super-site.

Figure 26: Pitch of the altimeter in Deruta super-site (flights 112 and 114).

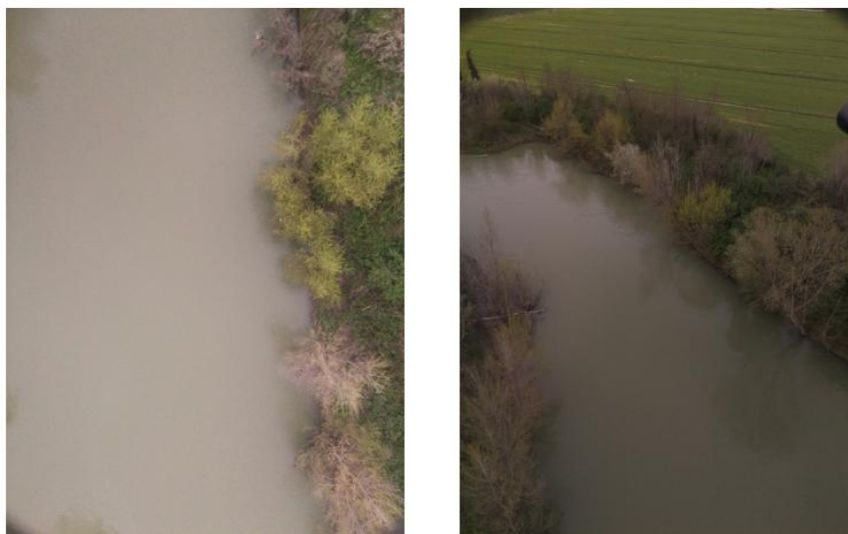
The images acquired by the altimeter illustrate the significant mispointing that can occur when the gimbal is malfunctioning (right panel of Figure 27). For comparison, the left panel shows the altimeter when the gimbal is operating nominally. When we have this strong mispointing, we can see that the altimeter is not pointing to the nadir and does not have any back-scattered signal.

Figure 27: Pictures taken by the altimeter when the gimbal has a normal position (left) and a wrong one (right).

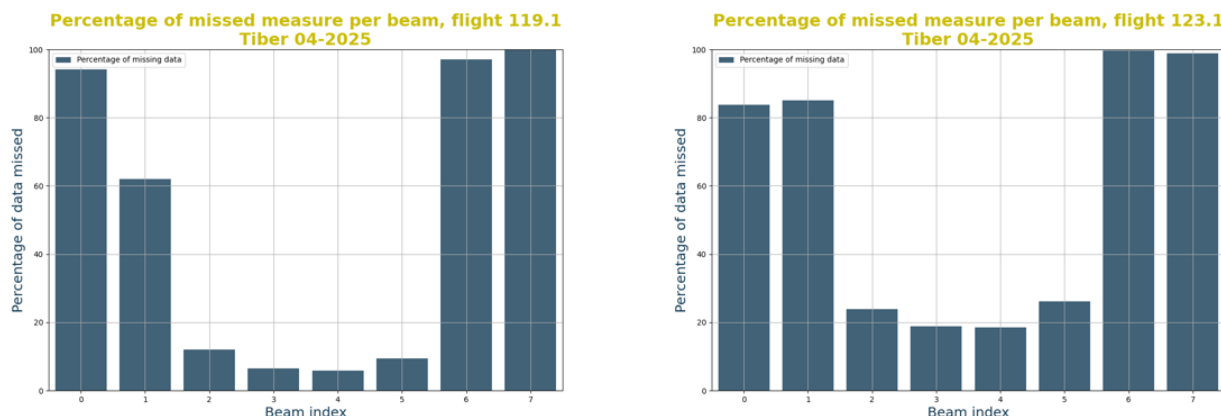
The LiDAR measurements show good results, with a low percentage of missing data on the two central beams (Figure 28). The higher percentage observed on flight 123 is due to the initial editing performed during processing, which excludes some outliers and counts them as missing data.

Figure 28: Missed measures per beam in Santa Lucia super-site (flights 119 and 123).

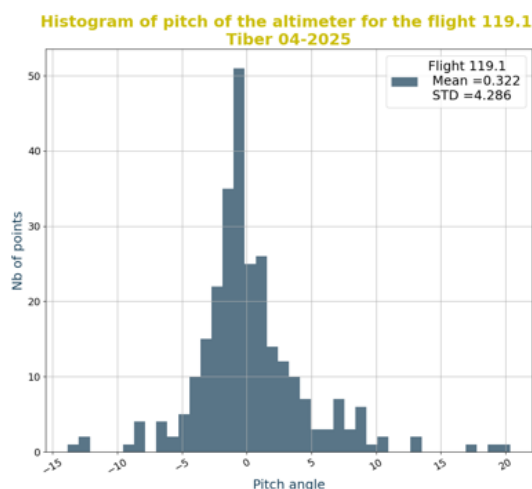
On both flights, the altimeter is well-centred regarding the pitch. The pitch standard deviation is a good information on the quality of the stabilization. This value is much lower than with the previous gimbal and is especially excellent on flight 123. On these flights, we do not have the gimbal issue seen on the Deruta super-site.

Figure 29: Pitch of the altimeter in Santa Lucia super-site (flights 119 and 123).
